Geotechnical Engineering Report
Mt. Zion Old School Baptist Church
Damage Study
Gilberts Corner
Loudoun County, Virginia

December 9, 1997

Geotechnical Engineering Report, Mt. Zion Old School Baptist Church Damage Study, Gilberts Corner, Loudoun County, Virginia (Our 972717)

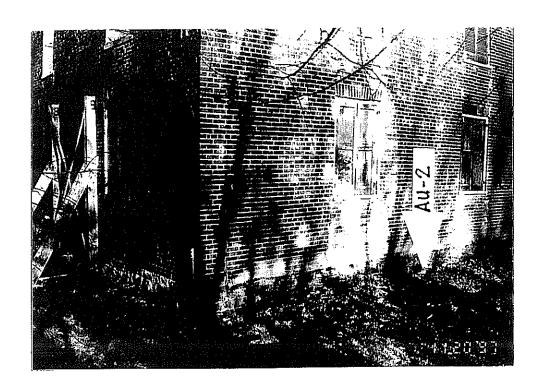
SOUTH WALL - ARROW POINTING AT AU-2

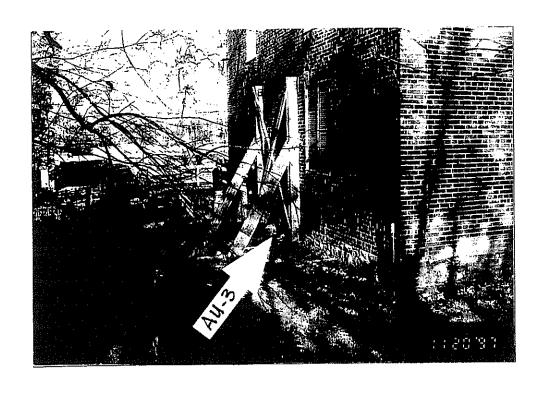
WEST WALL - ARROW POINTING AT AU-3

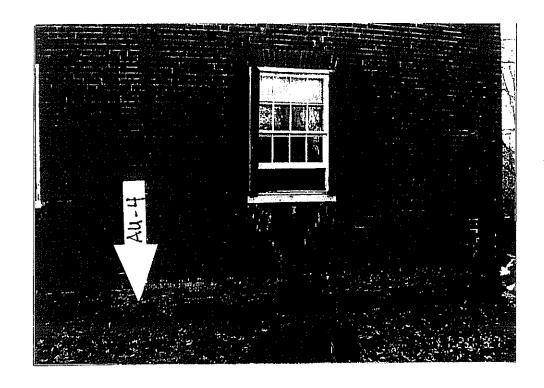
NORTH WALL - ARROW POINTING AT AU-4
